## "Full" Reserve Study

## Ridge at Rock Creek Marysville, WA

**Report #: 32285-0**  
**For Period Beginning: January 1, 2018**  
**Expires: December 31, 2018**

**Date Prepared: April 4, 2017**

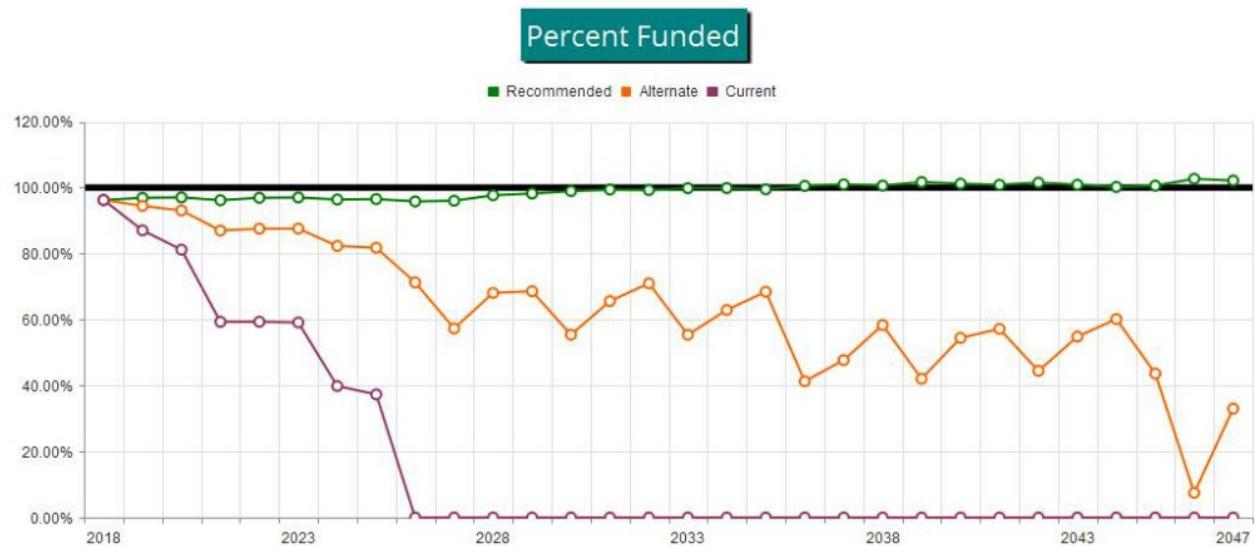
Figure 4

This figure shows the same information plotted on a Percent Funded scale. It is clear here to see how your Reserve Fund strength approaches the 100% Funded level under our recommended multi-yr Funding Plan.

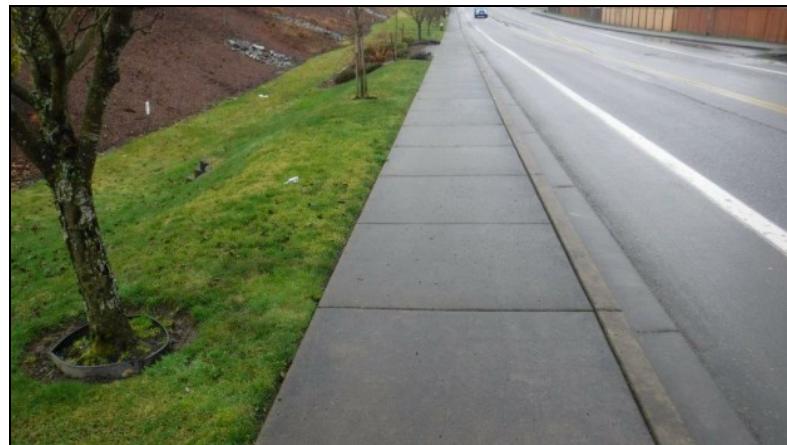
### Comp #: 100 Concrete - Repair/Replace

Evaluation: Concrete appeared in fair condition with only minimal cracking noted at this time.

As routine maintenance, inspect regularly and pressure wash for appearance. Repair any trip hazards (1/2" difference in height) immediately to ensure safety. Repair promptly as needed to prevent water penetrating into the base, which can cause further damage. Factors affecting the quality, service life of the concrete include; the preparation of the underlying soil and drainage, thickness and strength of concrete used, steel reinforcement (none likely), and amount and weight of vehicle traffic, if any and tree roots nearby.

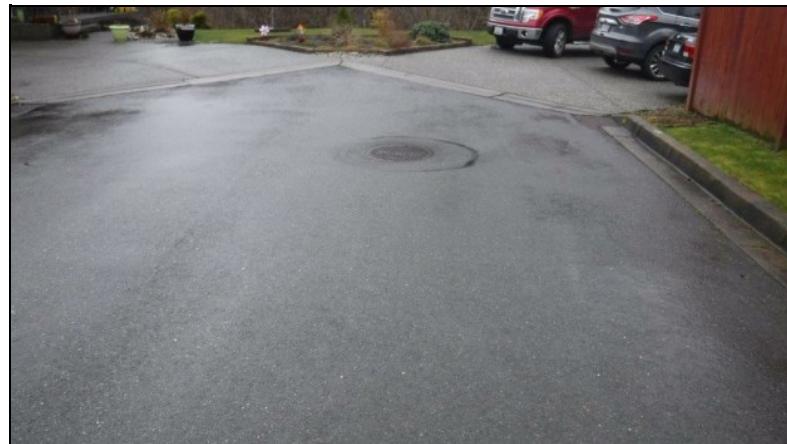
Evaluation: This area is a "private drive" and as such is likely not dedicated to the City of Marysville as are other roadways within the community. Generally good condition, with no widespread problems (cracking, excessive wear, alligator cracking) observed during our limited visual review. Note further observations concerning asphalt conditions, etc.

As routine maintenance, keep surfaces clean and free of debris, ensure that drains are free flowing, repair cracks, and clean oil stains promptly. Assuming proactive maintenance, plan to resurface at roughly the time frame below.

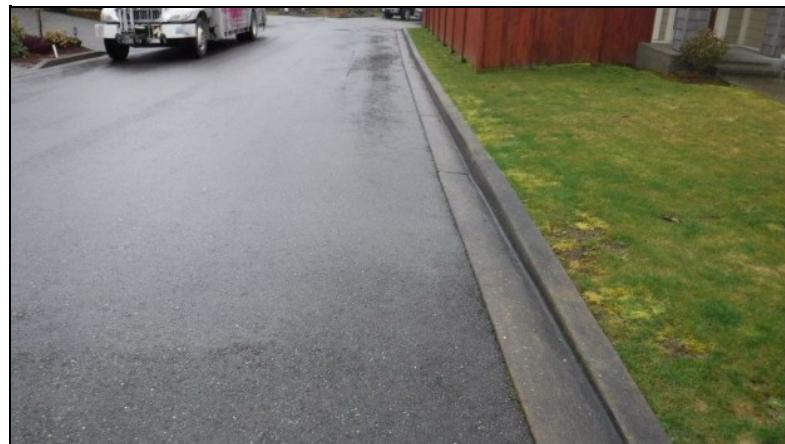
**Comp #: 121 Asphalt - Seal Coat & Repair**

Evaluation: Generally, the surface condition of the asphalt coating appeared to be in fair condition but no evidence of prior sealcoating.

Repairing asphalt before seal coating is imperative. Thorough surface preparation and dry weather during and following application, is key to lasting performance. The ideal conditions are when the air and surface temperatures are 50 degrees and rising, with low humidity and calm wind. Seal coating should never be done when showers are threatening. Incorporate any striping and curb repair into this project. Fill cracks with hot rubberized crack fill and clean oil stains promptly in between cycles as routine maintenance.

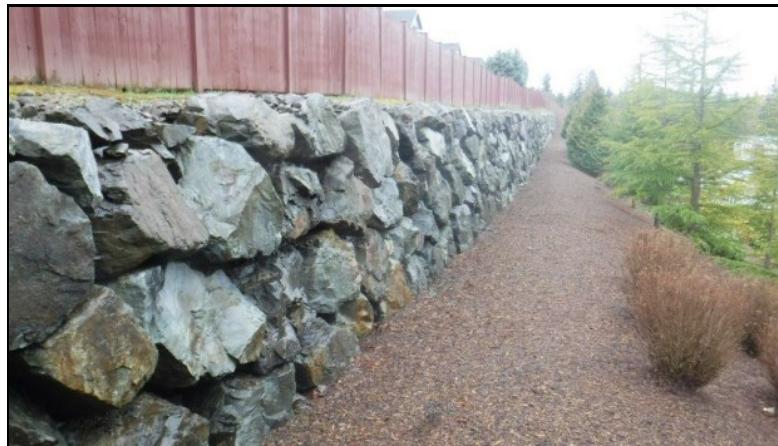
**Comp #: 157 Retention Walls - Repair/Replace****Quantity: Extensive amount**

Evaluation: Retaining walls at Rock Creek Association are a combination of stacked blocks, rockeries, and anchored panel types. Our limited observation revealed no indication of walls being extremely out of plumb, excess erosion or other obvious issues. Thorough analysis of a retaining wall is beyond the scope of a reserve study. If problems, including shifting, leaning, or cracking are observed or suspected, consult with an engineer (structural, civil, and/or geo-technical) for evaluation and repair recommendations. No reported problems at this time.

No information was provided to us concerning how the retaining wall was designed or constructed. Observation of drainage was not possible. Proper drainage on the uphill side prevents a backlog of water (water, if present, can add substantial weight and pressure to the wall). A backlog of water, if left unchecked, could damage or break the wall. Interior of drainage lines (or pipes) can be viewed by video using a remote miniature camera. Clean out the drain lines as often as needed to prevent decreased drainage. See component # 182 Drainage/Stormwater Sys for additional information. Utilize mobile evacuator service if needed. Inspect regularly and repair as needed using operating budget.

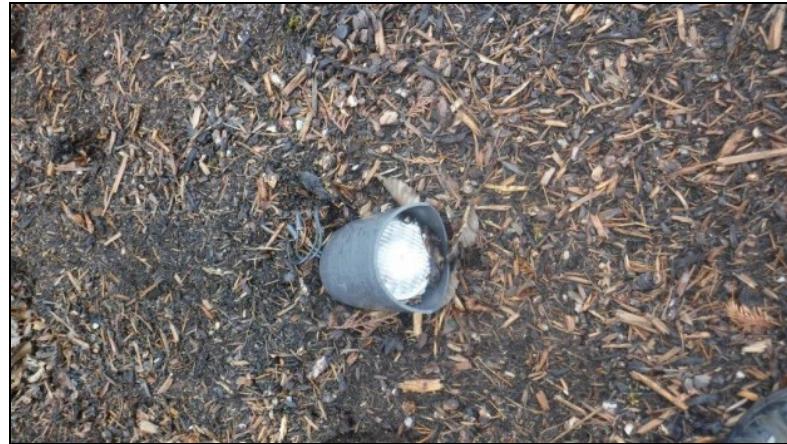
**Comp #: 164 Landscape Lights - Replace**

Evaluation: Fair condition noted with no significant damage/deterioration observed or reported to us. Observed during daylight hours; assumed to be in functional operating condition.

Best to plan for eventual large scale replacement at roughly the time frame below. Lighting is most efficiently replaced as a grouping to maintain consistent appearance and quality, and for cost efficiency, as multiple trip charges for electrician erase any savings by replacing sporadically. Check with local utility before replacing any group of lights, as energy savings rebate programs may be available.

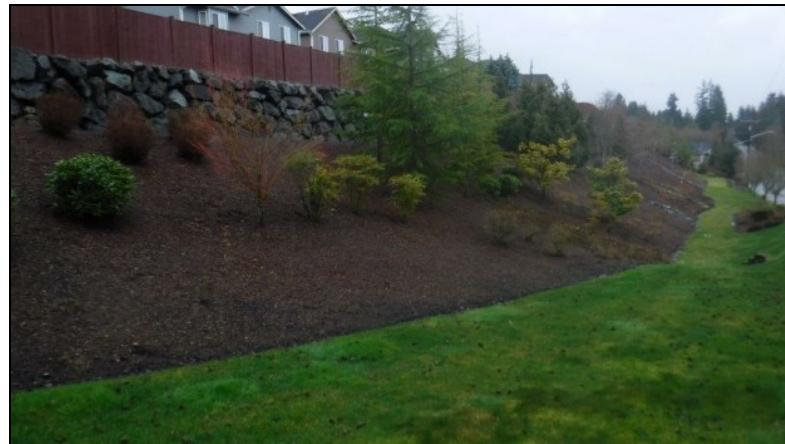
Evaluation: Common area landscape is in generally mature, healthy condition. Currently, landscaping maintenance is funded out of the operating budget.

Walk area each year with landscape contractor and perhaps landscape architect to assess the overall health, function and future needs of maintenance and refurbish to determine any adjustments that should be made to supplemental reserve funding noted below.

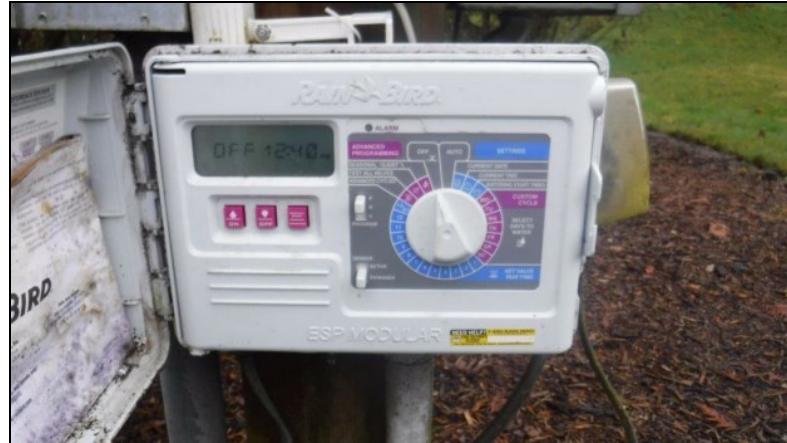
**Comp #: 175 Irrigation System - Repair/Replace****Quantity: Lines, heads, valves, etc**

Evaluation: Our visual observation of the irrigation system was limited as the majority of system components are below grade. No reports of repairs or problems.

As routine maintenance, inspect, test, and repair system as needed from operating budget. Follow proper winterization and spring startup procedures. If properly installed and bedded without defect, the lines could last for many years. Controls for the system can vary greatly in number, cost, and life expectancy - typically each controller is less than \$500. Other elements (i.e. sprinkler heads, valves) within this system are generally lower cost and have a failure rate that is difficult to predict. These elements are better suited to be handled through the maintenance and operating budget, not reserves.

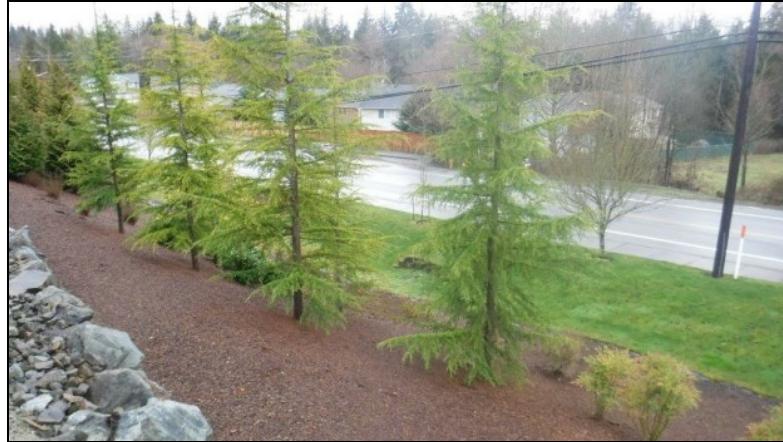
**Comp #: 190 Trees - Trim, Replace****Quantity: Numerous, adolescent**

Evaluation: This component applies only to trees planted in common areas. Declaration section 5.4 makes trees in parking strips adjacent to homes the responsibility of the adjoining homeowners. No specific problems observed or reported at this time. Trees are generally mature throughout community.

This component may be utilized for larger tree removal/trimming projects which do not occur on an annual basis. If the community has not already done so, consult with a qualified arborist to assess the appropriateness of current plantings and for a long term plan for the care and management of the trees within the community, balancing aesthetic with protection of association assets. Tree roots can be damaging to walkways, irrigation, underground utilities and building structure. Reserve funding recommend at level indicated below for periodic, larger tree removal/trimming needs. Track actual expenses and add funding to future reserve study updates if needed.

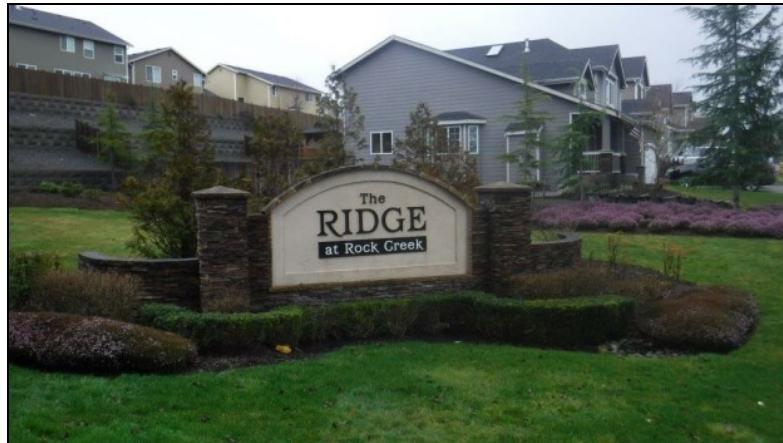
**Comp #: 200 Entry Signage - Replace**

Evaluation: Main sign appeared in fair, clean condition.

Inspect periodically, repair, clean, and touch up for appearance as needed using general maintenance funds.

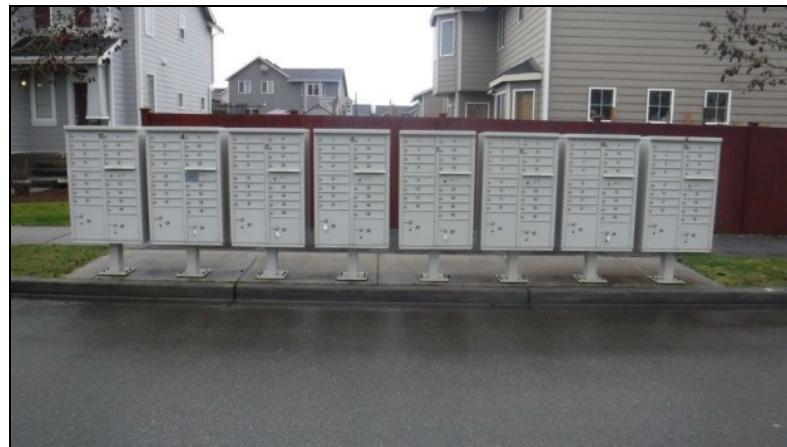
**Comp #: 205 Mailboxes - Replace****Quantity: (8) clusters**

Evaluation: Mailboxes appeared in fair, weathered condition. Mailboxes are not protected from the rain by a structure.

As routine maintenance, inspect regularly, clean by wiping down for appearance, change lock cylinders, lubricate hinges, and repair as needed from operating budget.

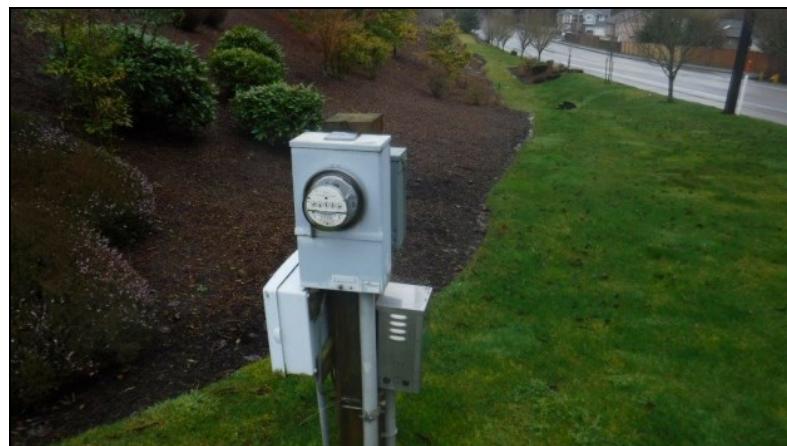
### Comp #: 905 Electrical System - Maintain/Repair

Evaluation: The common area electrical system appears to service only irrigation and tree lighting. Majority of electrical systems are not visible for review. Analysis of the electrical system beyond a limited visual review is not within the scope of a reserve study. No large issues or problems/defects were reported.

Manufacturing defects become known from time to time and certain site conditions can contribute to premature deterioration of electrical components. Periodic inspections and maintenance by a master electrician may become necessary. Some associations employ infrared or other testing methodologies to identify potential trouble spots.
