Full Reserve Study

The Ridge at Rock Creek

Marysville, WA
11/13/2012

Report # 1100

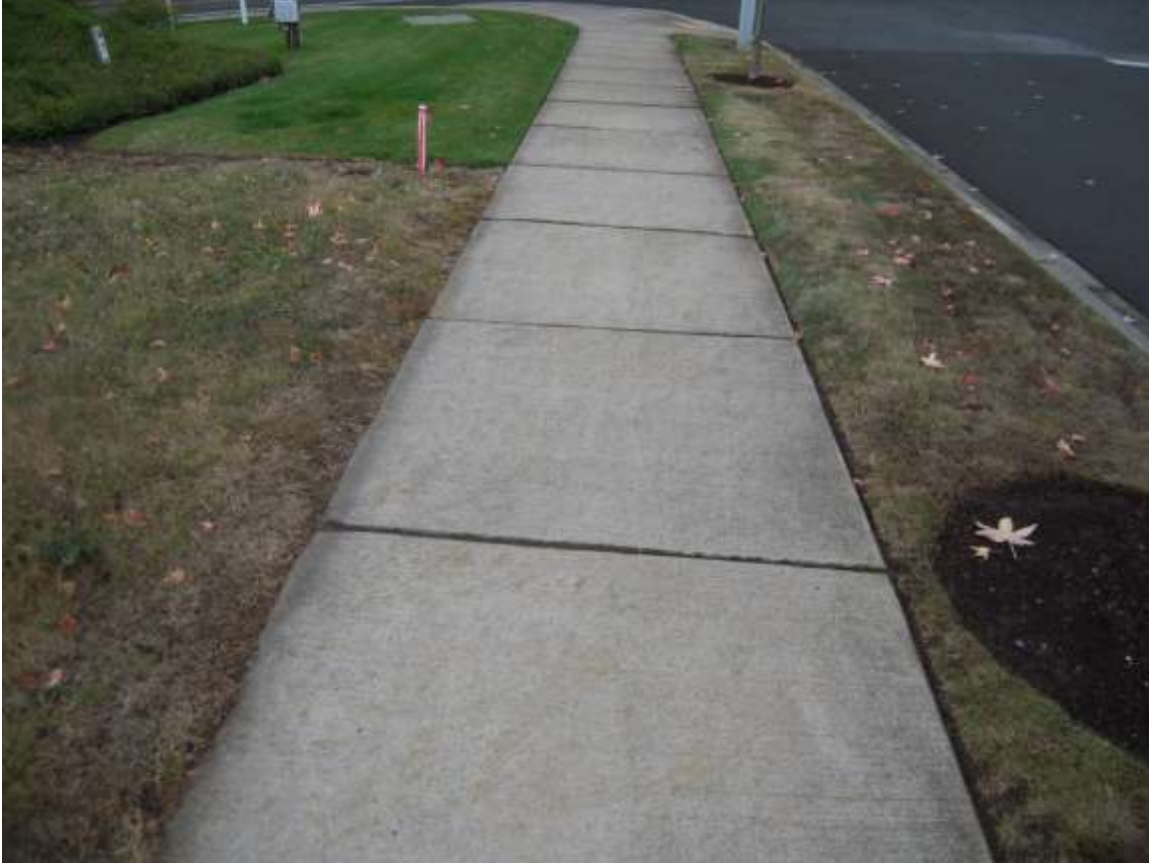
Component: Concrete – Repair/Replace

Comments: Fair condition with no damage or unexpected deterioration observed. We suggest regularly inspections of concrete, with repair as needed to prevent water penetration and damage. Periodically pressure wash for appearance and repair any trip hazards immediately to ensure safety. We do not expect large-scale or total replacement within the scope of this study. No reserve funding suggested.

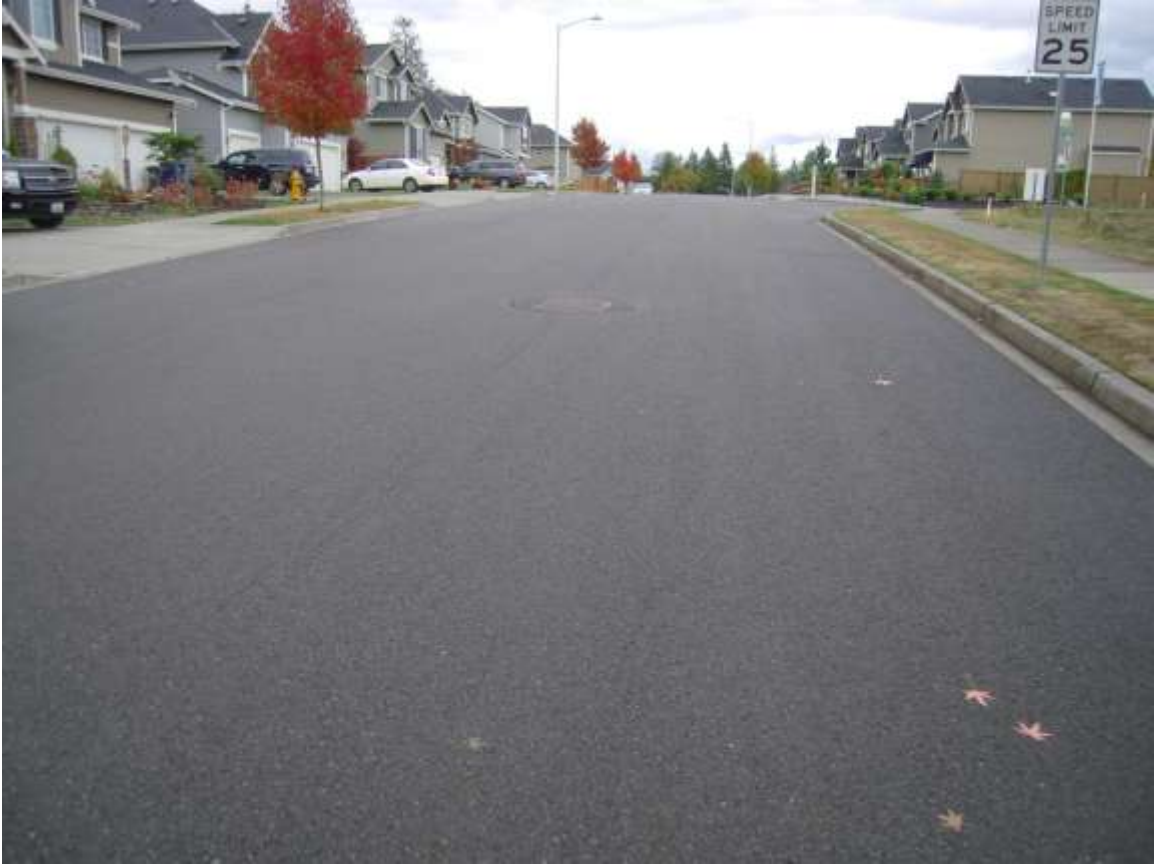
Component: Asphalt – Maintain/Repair/Replace

Comments: The asphalt is reportedly public streets – therefore the association is not responsible to maintain/repair/replace the asphalt. No reserve funding required.

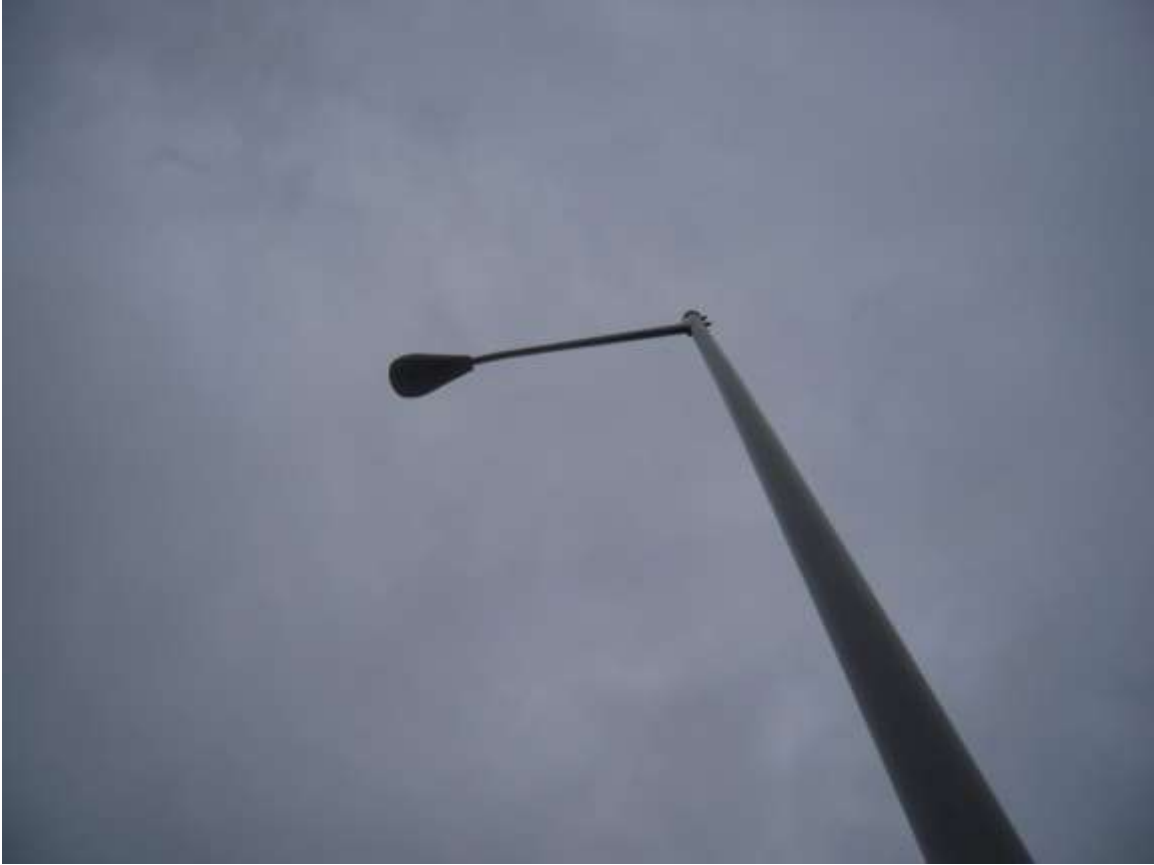
Component: Pole Lights – Replace

Comments: The pole lights appear to be responsibility of the city to maintain/repair/replace. No reserve funding required.

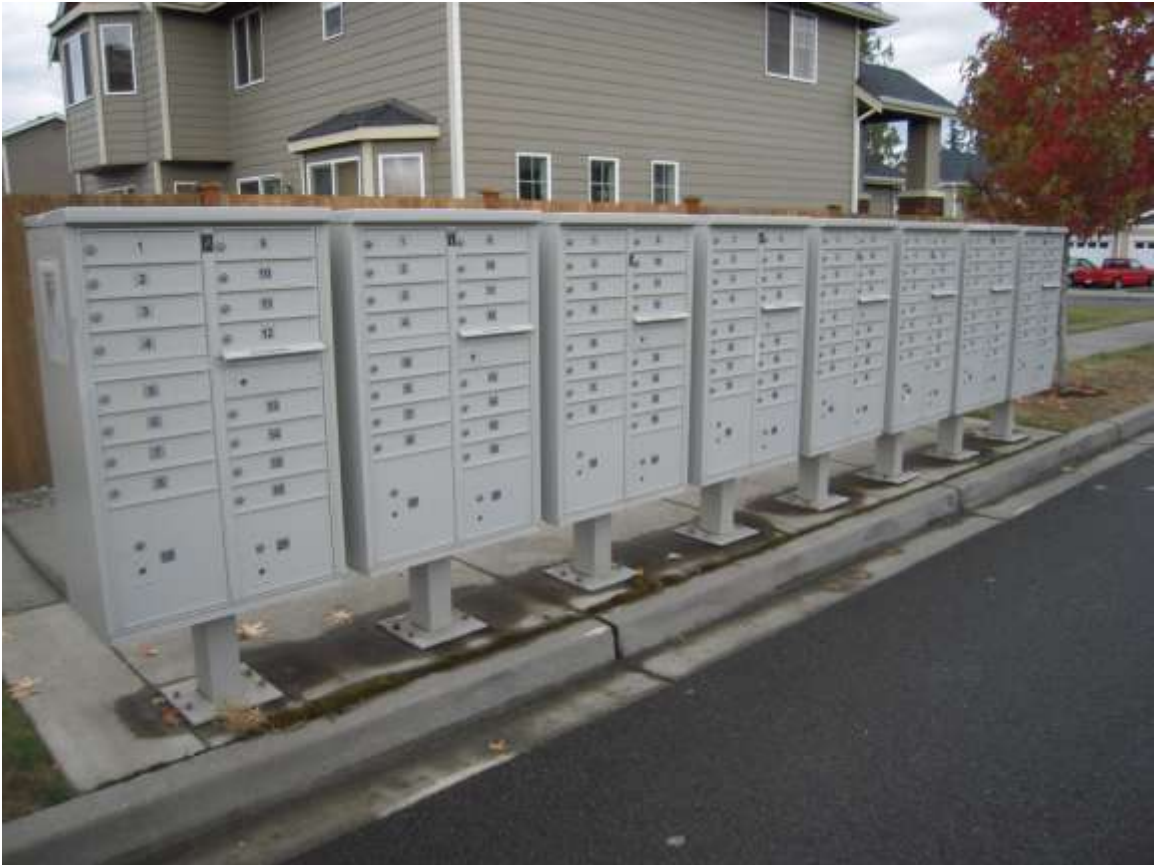
Component: Mailbox Clusters – Replace

Comments: Fair condition observed. Inspect regularly, clean and repair as needed from general maintenance budget. Best to plan for total replacement at roughly the time frame below due to constant usage and wear over time.

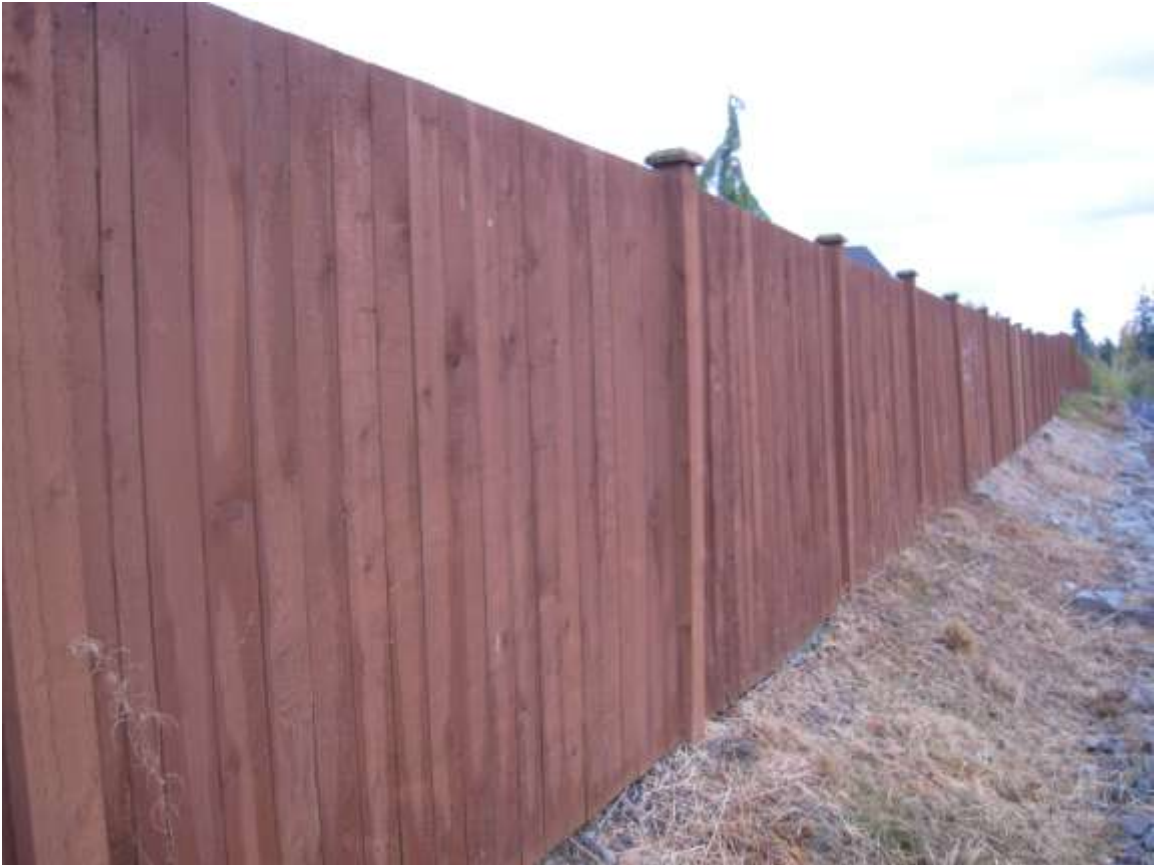
Component: Wood Fence – Replace

Comments: Fair condition with no significant instability or damage noted. Inspect regularly for any damage or deterioration and repair as needed. Try to avoid contact with the ground and surrounding vegetation. We suggest planning to replace the wood fence at roughly the time frame below.

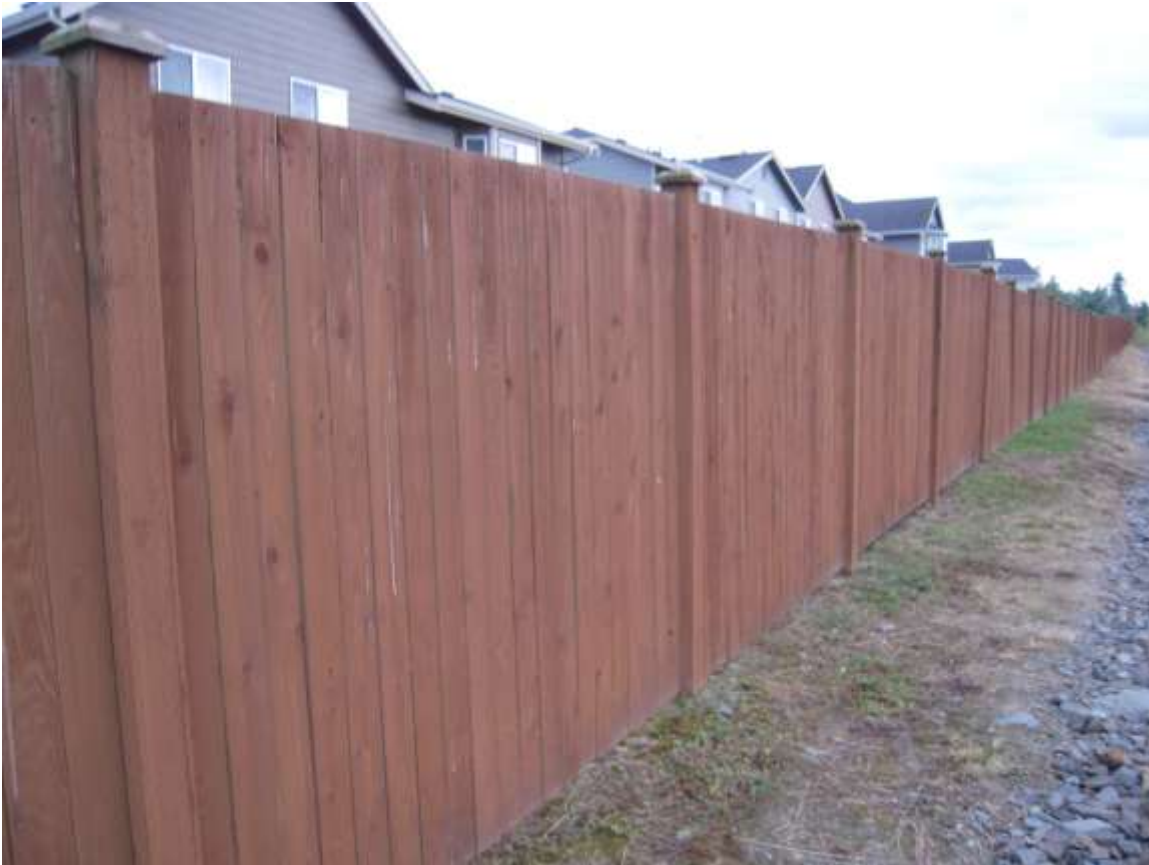
Component: Wood Fence – Stain

Comments: Fair condition observed. We suggest regular stain/paint for appearance and protection of wood. Plan to stain/paint both sides of the fence at the interval indicated below.

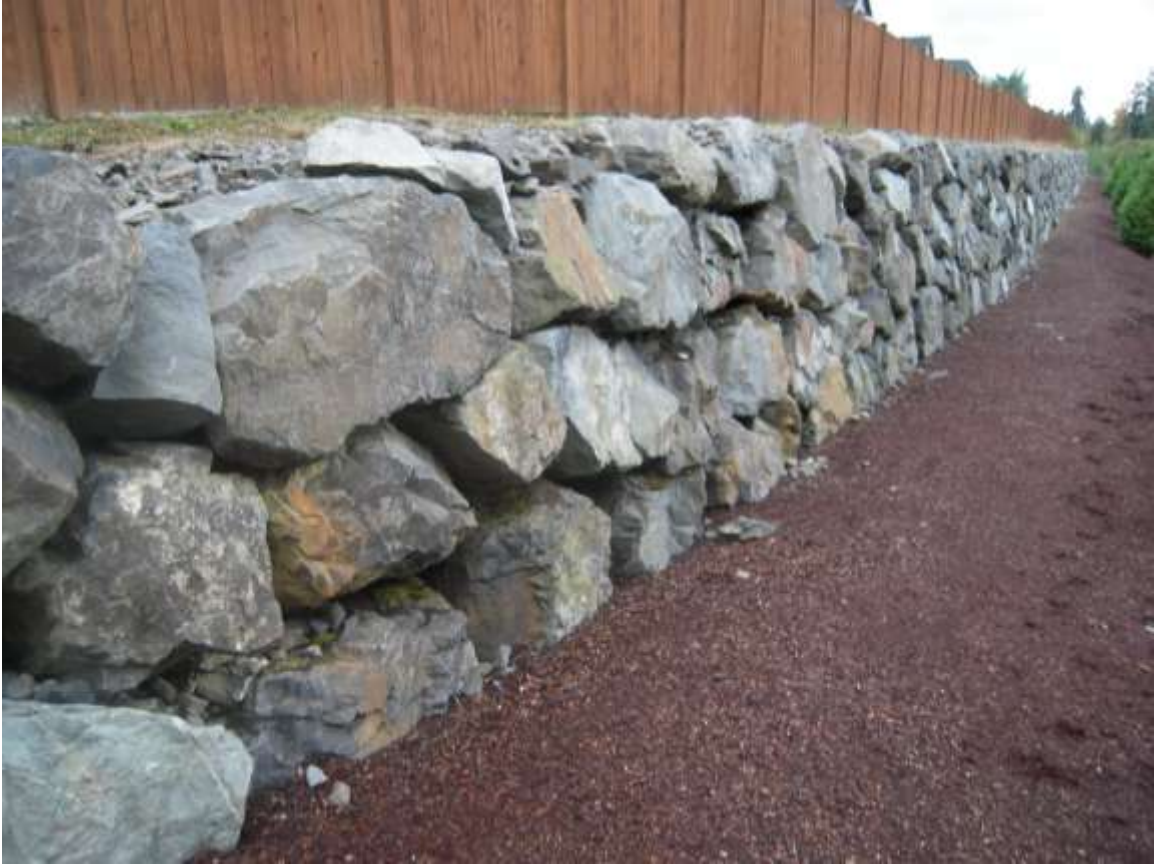
Component: Rockeries/Retaining Walls – Replace

Comments: Rockeries appear to be in stable condition with no significant erosion noted. We assume that the rockeries were properly installed with adequate base and surrounding drainage. If areas of deterioration emerge, consult with civil or geotechnical engineer for repair scope. No basis for reserve funding at this time.

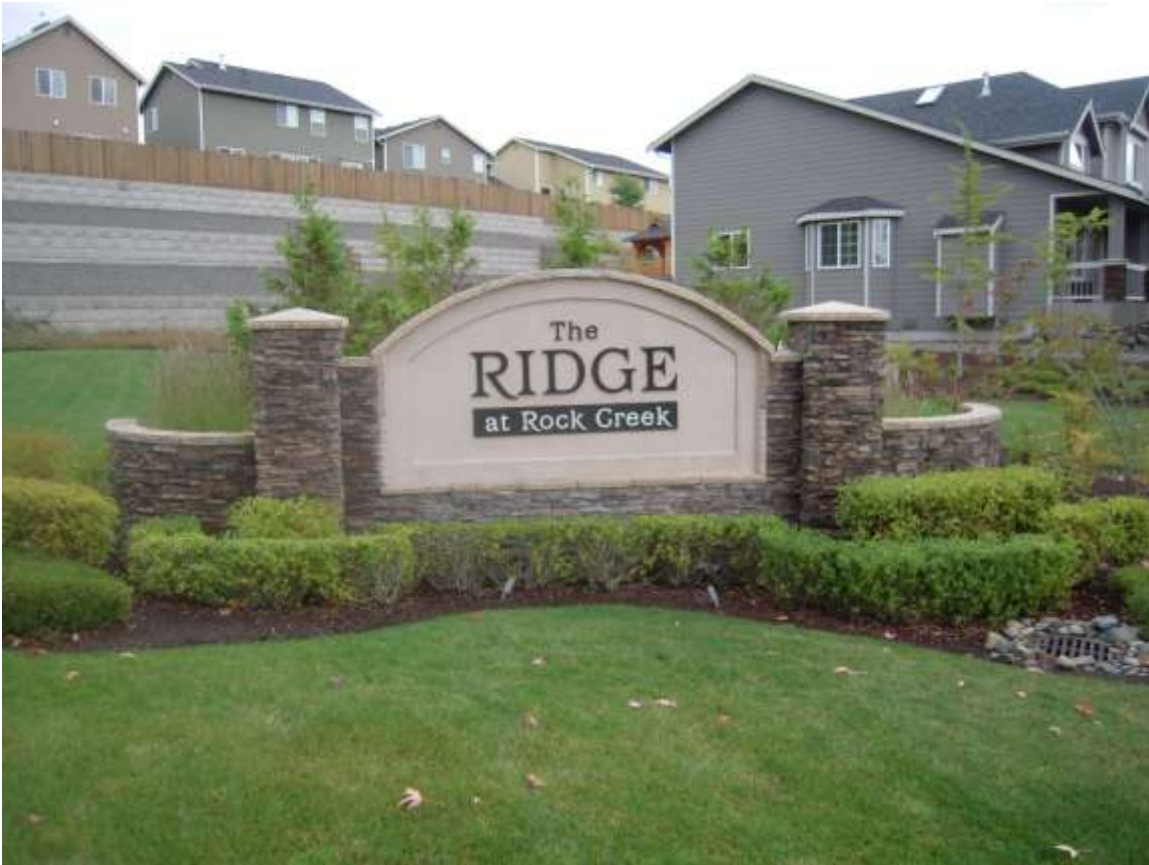
Component: Entry Monument – Replace

Comments: Fair condition of entry monument observed during our site inspection. No damage or unusual wear. Sturdy component that can last for extended period of time if not damaged or abused. Clean and apply touch up paint for appearance as needed from operating funds. No predictable expectation for replacement within the scope of this report, no reserve funding suggested.

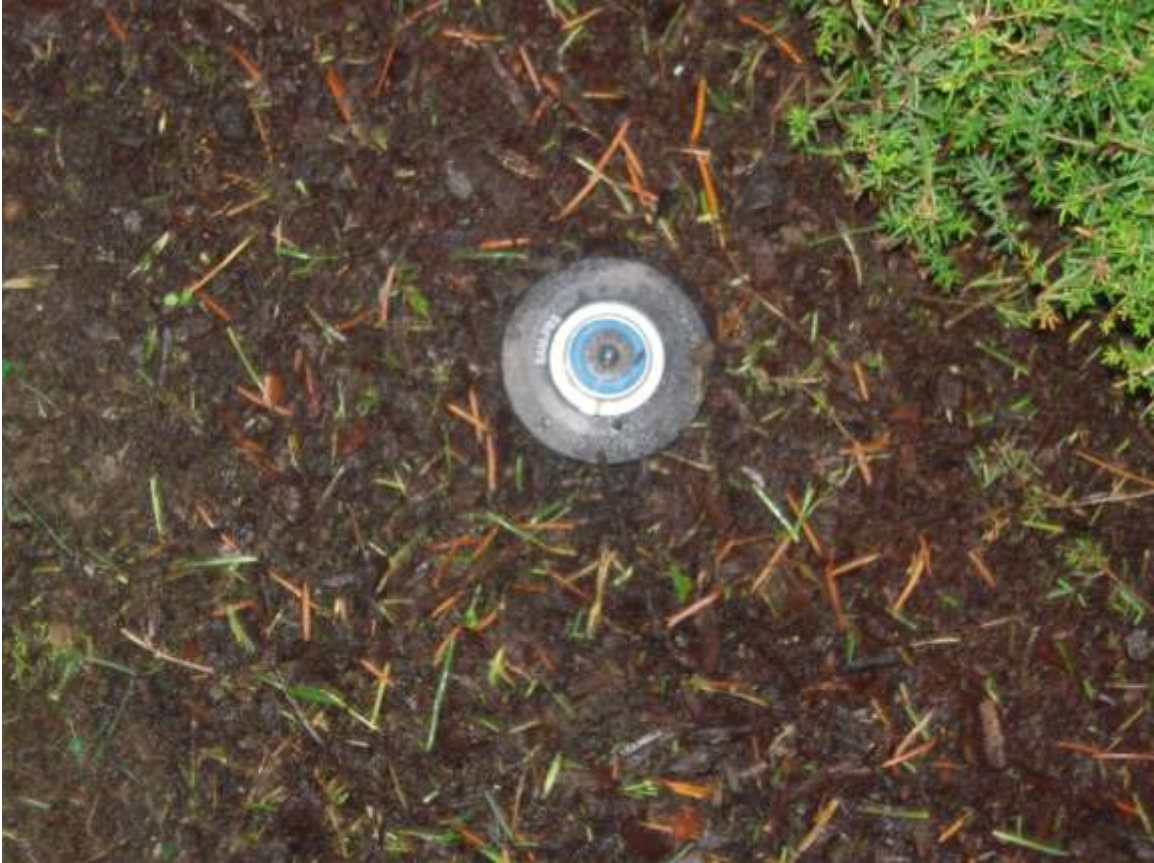
Component: Irrigation System – Refurbish

Comments: No reported problems at this time. Regularly test system and repair as needed from maintenance budget. Follow proper winterization and spring start up procedures. If the system was properly installed the elements within this component are generally low cost and have a failure rate that is difficult to predict. Best suited to be handled thru the operating budget. No basis for reserve funding at this time.

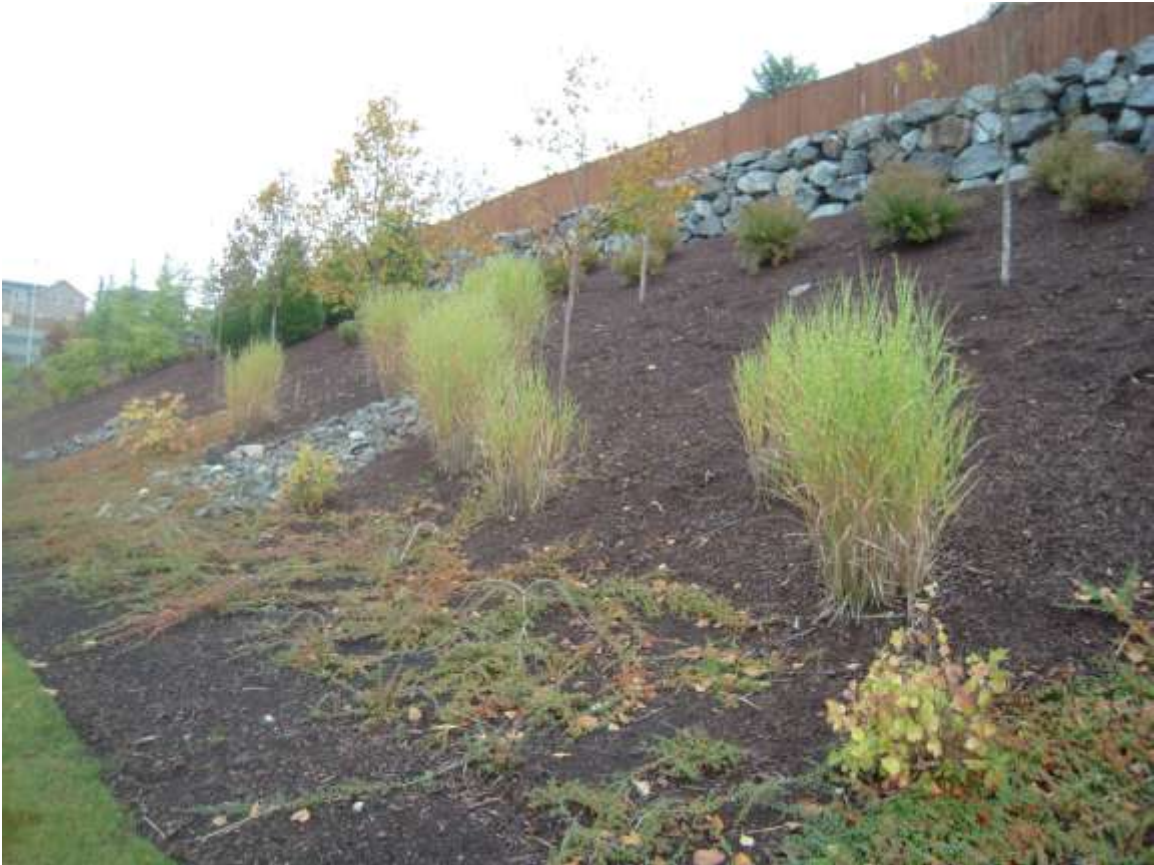
Component: Landscaping - Refurbish

Comments: This component may be utilized for setting aside funds for larger expenses that do not occur on an annual basis, such as: large-scale plantings, bark mulch or landscape improvement projects. Best to plan for an allowance for large-scale landscape improvement projects.

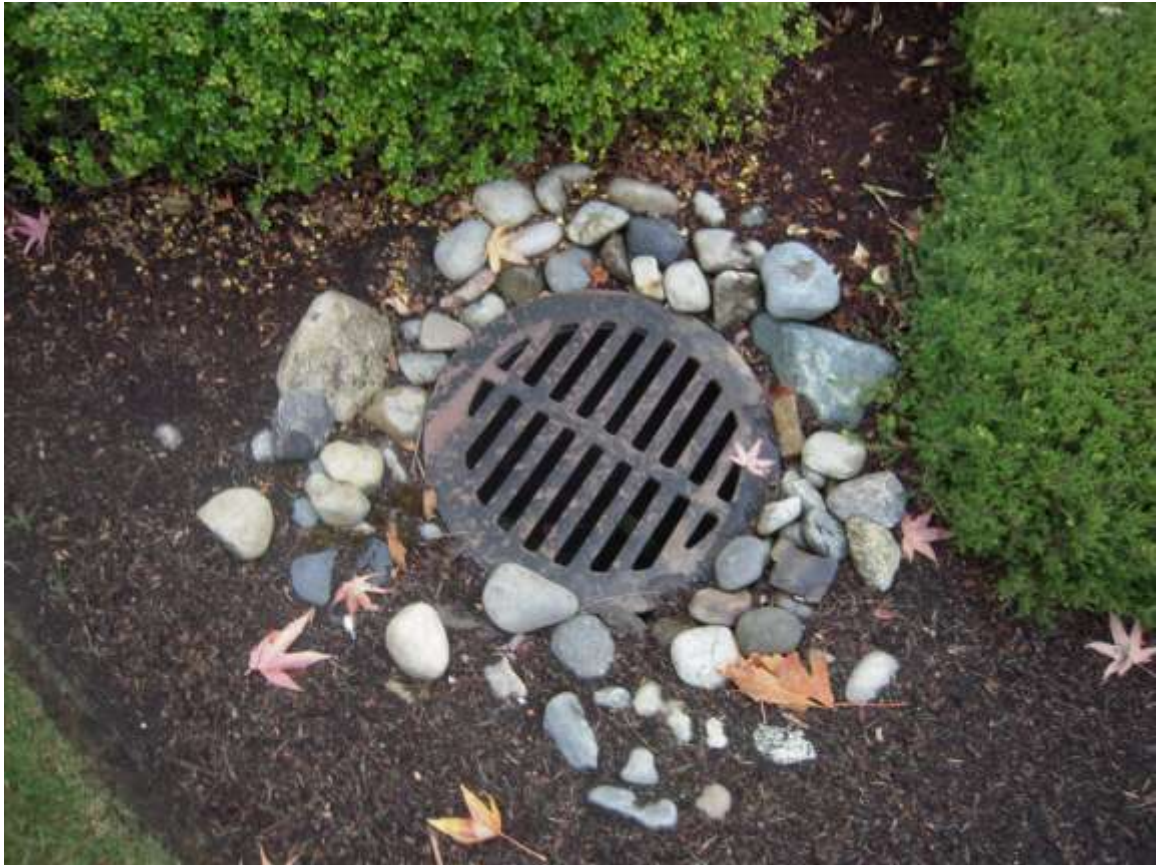
Component: Drainage System – Repair/Refurbish

Comments: Fair condition with no reported problems at this time. We assumed the community was properly designed with adequate provisions for drainage. As routine maintenance, inspect regularly and keep drains and grates free of debris to ensure water is evacuating as designed. Pump out sediments if needed utilizing mobile evacuator service fund from the maintenance budget. We do not expect any large-scale expenses within the scope of this study. No reserve funding suggested.
